T 19S, R 12E, M W

LAND CORNER RECORD

CORNER RECORD (SEARCH)

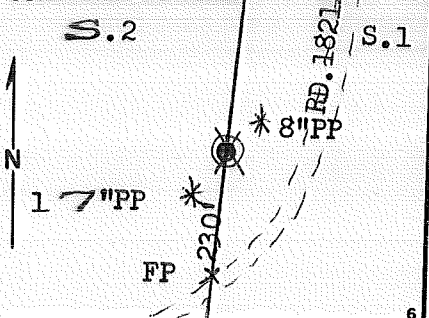
CORNER DIAGRAM

N O T H I N G

Two rotting stumps w/ "BT" scribes

Set 5/8" x 30" Steel Rod, rising 5", center punched and stamped "A",
in mound of stones.

An 8" Ponderosa Pine bears N73°E 58.45 feet, B&S "1/4 S1 BT", nail in W side;
A 17" Ponderosa Pine bears S28°W 46.88 feet, B&S " 1/4 S2 BT", nail in E. side.

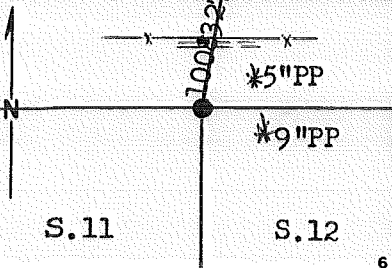
CORNER DIAGRAM 1821

N O T H I N G

In old clear cut area, plowed for tree planting.

Three pine stumps, sawn, w/ "BT" scribes

Set 2" x 20" Brass-Capped Steel Pipe, rising 6" in mound of stones, stamped as shown:

T19S R12E
2.1
11|12

A 5" Ponderosa Pine bears N46^OE 52.4 feet, B&S "S1 Cor BT";

A 9" Ponderosa Pine bears S88^OE 75.6 feet, B&S "S12 BT".

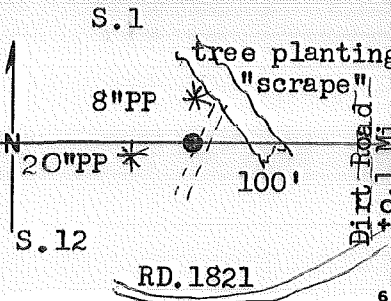
CORNER DIAGRAM

Cor. Tree (Now log w/stump attached) apparently ripped out for now-abandoned road.

S.12--Rotted, sawn stump w/ "BT" scribe.

S.1-- BT Torn out for tree planting.

Set 2" x 32" Brass-Capped Steel Pipe, rising 7" in a mound of stones, about 100 feet west of a dirt road and about 500 feet north of Rd. 1821, stamped as shown:

A 20" Ponderosa Pine bears S72°W 38.33 feet, B&S "S12 BT", w/nail in N. side;

An 8" Forked Ponderosa Pine bears N02°E 93.21 feet, B&S "1/4 S1 BT", w/nail in E. side.

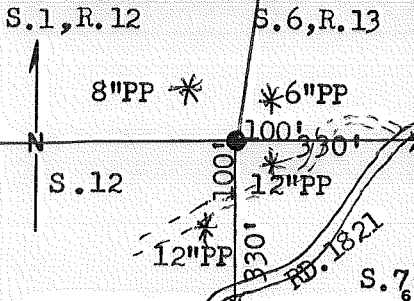
CORNER DIAGRAM

Nothing

All rotted, sawn stumps w/ "BT" scribes.

Set 2" x 32" Brass-Capped Steel Pipe, rising 5" in a mound of stones,
stamped as shown:

T19S
 R12E | R13E
 1.6
 12 | 7

A 6" Ponderosa Pine bears N30°E 72.2 feet, B&S "S6 R13E BT";
 A 12" Ponderosa Pine bears S86°E 69.5 feet, B&S "S7 R13E BT";
 A 12" Ponderosa Pine bears S28°W 118.0 feet, B&S "S12 R12E BT";
 A 8" Ponderosa Pine bears N50°W 105.3 feet, B&S S1 R12E BT".

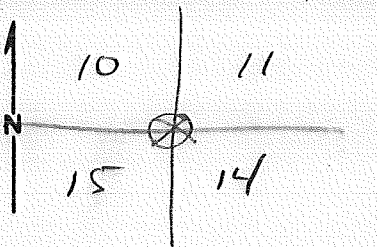
CORNER DIAGRAM

SFNF From found BTs, set nail at the point that best fit the Bearings & Distances.
Tied corner to 1992 survey of LunaBess P.T. 2

FD 4 BTs
20" P Pine stump N62°W 30.3' (46 LKS) Scribing Visible
26" P Pine " S55°E 55.6' (84 LKS) burnt over
24" P Pine " S43°E 56.2' (85 LKS) Scribing Visible
36" P Pine " N50°W 11.2' "17 LKS" " " 3

From location tag on E side of RD 036 go 660' East to corner
Found old cruiser post in mound of stone S38°E 6.7 ft. Its location does not fit the R.Ts. NE BT had an old loc. tag on it. 4

Set 10" spike at position determined from B T's

21" PPine N46°W 12.2 FT, nail in East base w/ location post

16" " S 85°E 32.3 FT, nail in North base " " "

metal post 3' North w/ location tag

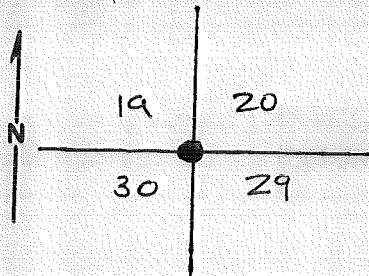
CORNER DIAGRAM

SF/NF

SW & SE BT's. Set corner by dist./dist. intersect. From the corner position the Original BT's are as follows:
A P. P. stump, 26" dia. S.58° W., 118 lks. (77.9 ft.) with bottom of blaze & chaining notch.
A P.P. stump, 24" dia. S.44° E., 24 lks. (15.8 ft.) with bottom of blaze & chaining notch. Both Stumps have been burned.
Remains of a P.P. stump in the NE BT's location.
No evidence of the NW BT.
Old location board on Rd. 220, S.76°E., 114 ft. from corner.

2 1/2" dia X 30" long steel pipe, surmounted by 2 1/2" Brass cap; 26" in the ground, surrounded by mound of stone. Penny @ base of pipe.

PP. 17 " dia. N 17° E 10.5 ft. mkd T195 R12E S20 B.T.

PP 18 " dia S 28° E 19.0 ft. mkd T195 R12E S29 B.T

PP 13 " dia S 27° W 7.1 ft. mkd T195 R12E S30 BT

PP 8 " dia N 75° W. 38.9 ft. mkd X B.T

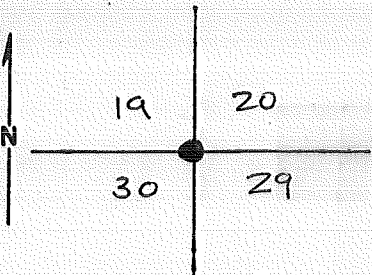
CORNER DIAGRAM

SF/NF

SW & SE BT's. Set corner by dist./dist. intersect. From the corner position the Original BT's are as follows:
 A P. P. stump, 26" dia. S.58° W., 118 lks. (77.9 ft.) with bottom of blaze & chaining notch.
 A P.P. stump, 24" dia. S.44° E., 24 lks. (15.8 ft.) with bottom of blaze & chaining notch. Both Stumps have been burned.
 Remains of a P.P. stump in the NE BT's location.
 No evidence of the NW BT.
 Old location board on Rd. 220, S.76°E., 114 ft. from corner.
