T 14S R 9E M Will

USDA-FOREST SERVICE

CORNER RECORD (SEARCH)

T 14 S. R. 9 E. R.D. Sisters County Deschutes
Merid. WILLAMETTE N.F. DESCHUTES State OREGON

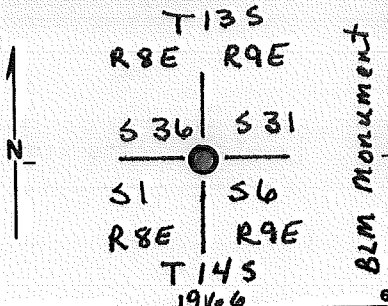
CORNER DIAGRAM

3" brass cap on 2 1/2" galvanized pipe

- A 7" Ponderosa bears N 24° E @ 9.5' Well healed
- A 6" Ponderosa bears N 64° W @ 17.7' Well healed
- A 7" Ponderosa bears S 57° W @ 39.3' Well healed
- A 8" Ponderosa bears S 31° E @ 46.5' Well healed
- Rotten + down 10" ? Ponderosa bears N 45° W @ 13'-18'

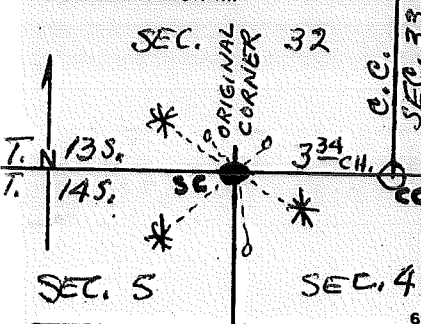
CORNER DIAGRAM

A #4X18" STEEL ROD IN A MOUND OF STONE.

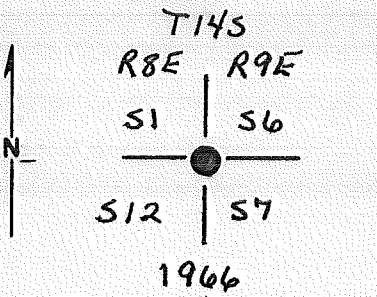
CORNER DIAGRAM¹

3" Brass Cap on Galvanized steel pipe
Rising 8" in good condition
*** For older Search Infor.
See T14S R8E: E-25**

REMARKS
1982 - FD 3" BLM brass cap rising 8" above ground in good condition
Steel post 30 ft. North w/ 54-2 & 54-4 signs.
16" P. pine snag NW quad 145 RBE S
8" " " NW quad scribed T145 RBE S1 BT 8" P. PINE 568°W 20±ft
8" " " N24°E 10±ft " T145 R9E S6 BT Healed over.
10" " " SE Healed over

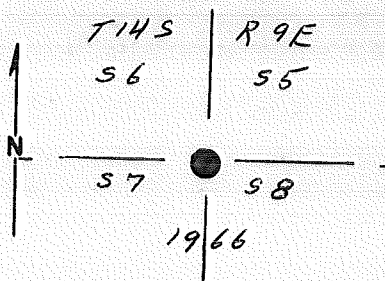
CORNER DIAGRAM

A 3" Brass Cap on 2 1/2" galvanized pipe

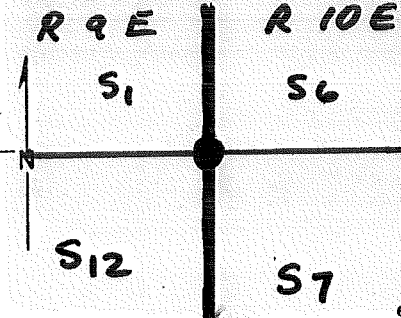
CORNER DIAGRAM PER LEGEND

STONE: 14" X 12" X 4" WITH ONE GOOD CHISEL MARK, LYING ON TOP OF GROUND.
 A #4 X 24" STEEL ROD WITH PLASTIC CAP MARKED "P.C." LYING ON TOP OF GROUND.

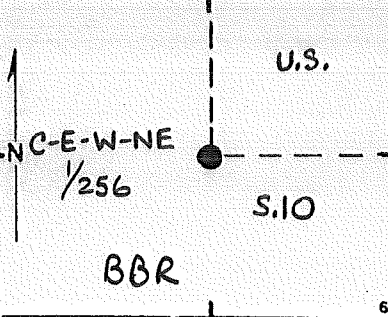
CORNER DIAGRAM per legend

Fd 3" BC RSG. 0" IN COLLAR OF STONE.
SEE NOTE BLOCK 12

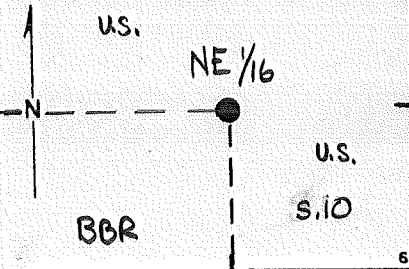
CORNER DIAGRAM, per legend

DESCRIBE CORNER MONUMENT FOUND
Fd. 3" BC Rsg. 5"

DESCRIBE BEARING TREES OR OTHER OFFICIAL ACCESSORIES FOUND
14" P. Pine brs N75°E @ 60²⁹ scb. healed over
10" " " S17°E @ 56²⁸ " vis, but no legible
8" " " N08°W @ 46³⁹ " S10 NE 1/16

DESCRIBE CORNER LOCATION RELATIVE TO NEAR-BY FEATURES, ALSO HOW TO REACH CORNER
SW tree missing, presumed destroyed in
RV lot construction.
Located @ NE cor of RV lot

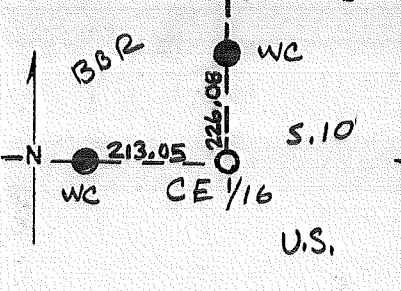
CORNER DIAGRAM per legend

DESCRIBE CORNER MONUMENT FOUND TRUE CORNER FALLS IN SWAMP.

WEST W.C. - Fd 3" BC set in concrete,
NORTH W.C. - Fd 3" " " " "
(SEE BLK 9 FOR DESCRIPTIONS)

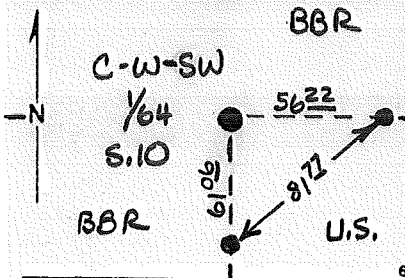
CORNER DIAGRAM, per legend

Fd. 5/8" IR w/1/2" Alum. CAP.

Searched w/metal locator in immediate area for other IR's and found none.

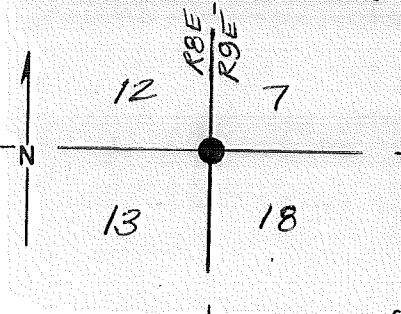
CORNER DIAGRAM PER LEGEND

DESCRIBE CORNER MONUMENT FOUND 3 1/4" BLM brass cap rising 7" in good condition. Stone at NW base of cap.

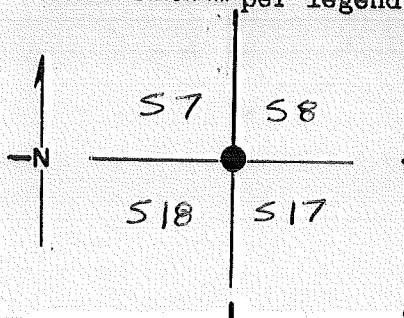
CORNER DIAGRAM per legend

DESCRIBE CORNER MONUMENT FOUND
3 1/4" BLM Brass cap on 2 1/2" pipe
Rising 10" above ground in good condition in stone mound.

DESCRIBE BEARING TREES OR OTHER OFFICIAL ACCESSORIES FOUND
Org. 27" pine stump N 50° W scribed T14S R9E S
30" P. pine S 35° W 54 Iks scribing visible now a STUMP
20" P. pine S 28° E 117 Iks " "

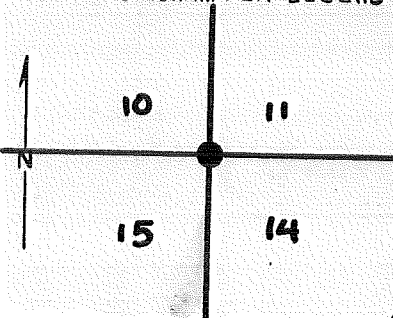
CORNER DIAGRAM PER LEGEND

STONE: 20" X 15" X 7" WITH TWO NOTCHES VISIBLE
3" BRASS CAP IN CONCRETE PIER FLUSH WITH GROUND SURFACE.

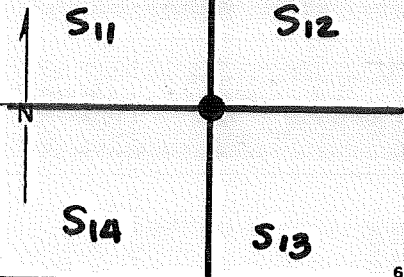
CORNER DIAGRAM PER LEGEND

3" BRASS CAP ON STEEL PIPE FLUSH WITH GROUND LEVEL, SET BY DOUBLE PROPORTION SURVEY 1977

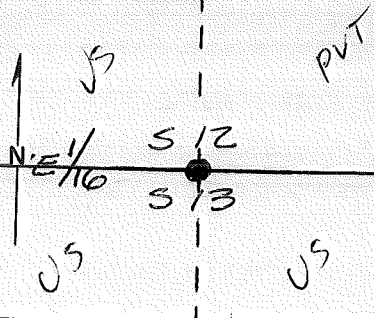
CORNER DIAGRAM

Fd. 2 1/2" BRASS CAP ON 2 1/2" O.D.I.P.
AT A FENCE CORNER, RISING
0.5' ABOVE GROUND

REPLACED B.T.' TAGS WITH OBTAINED DATA

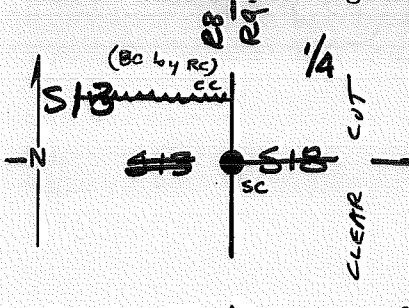
MACCLUNG STONE AREA HAS BEEN CATTED HEAVILY FOUND ONE STONE OF APPROX. SIZE SEEMS TO HAVE BEEN ON EARTH RECENTLY

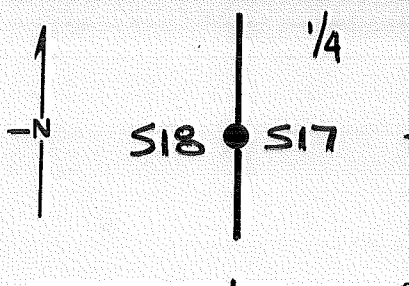
FOUND A STONE 18X11X8

POSSIBLE THE ORIGINAL BUT NO MARKS

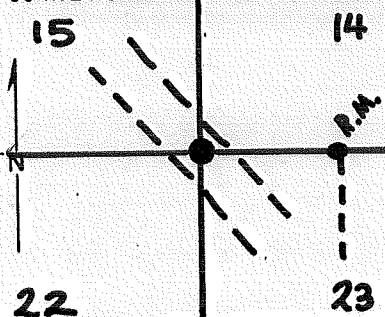
CORNER DIAGRAM PER LEGEND

**#5 STEEL ROD BURIED 4" IN ROAD
BLACK BUTTE RANCH BOUNDARY MARKER, A #5 ALUM-CAPPED STEEL ROD.**

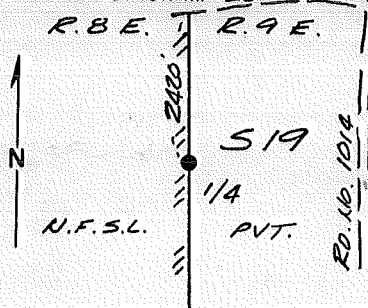
18" x 14" x 6" stone set by John H. McClung
orig. survey cont. no. 134 dated Aug. 22, 1870
w/ no apparent markings set well in ground.
orig. call: 19" x 10" x 8", No B.T.s called for

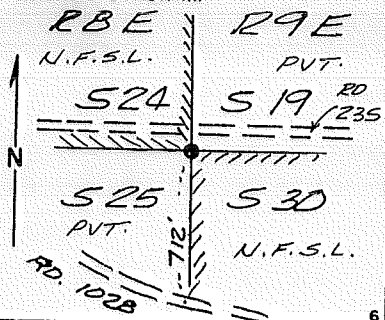
CORNER DIAGRAM

Fd. 11x12x7 stone believed to be out of position, w/ no markings

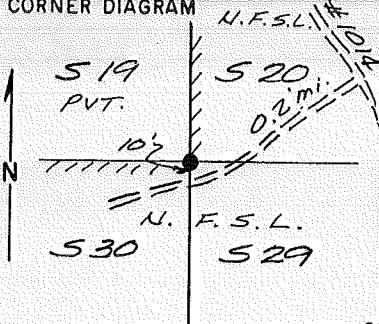
CORNER DIAGRAM

14"x 9"x 4" stone w/ no markings used by timber cruisers. I did ^{not} hold it's position orig. stone call: 14"x 11"x 4"

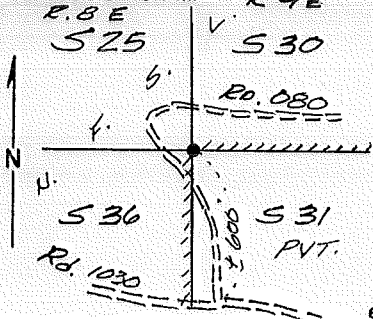
CORNER DIAGRAM

Fd. 16" x 16" x 10" stone w/ no markings set firmly in ground in logging skid trail used by timber cruisers. Orig. stone call: 18" x 12" x 7"
I did not hold stone as corner

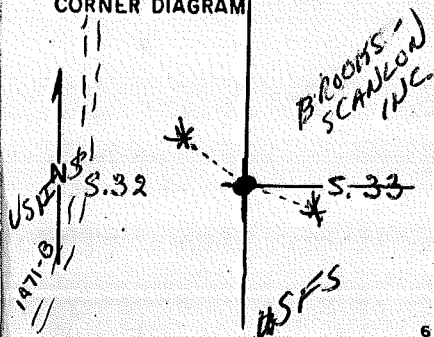
CORNER DIAGRAM

STONE, 18" X 16" X 10", RSG. 9" ABOVE GROUND WITH "1/4" CHISELLED INTO NORTH FACE
