SURVEY DIAGRAM

T 15 S R 9 E

CORNER RECORD (SEARCH)

LL93113

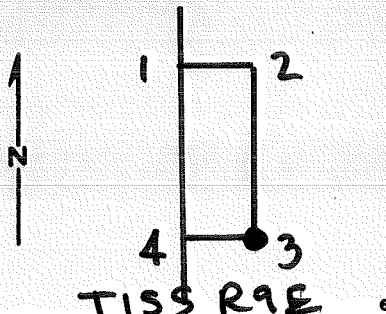
CORNER DIAGRAM

DESCRIBE CORNER MONUMENT FOUND

Not Orig. Set

DESCRIBE BEARING TREES OR OTHER OFFICIAL ACCESSORIES FOUND

Set Monument from survey Rising 1"

5" P. pine brs N15°W @ 10.4 feet marked X BT
 A 2 1/2" BCSP MKD COR 4 , Brs S89°25'02"W @ 122.00 feet

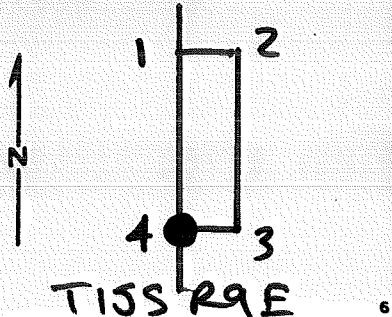
CORNER DIAGRAM

DESCRIBE CORNER MONUMENT FOUND

Not Orig. Set

DESCRIBE BEARING TREES OR OTHER OFFICIAL ACCESSORIES FOUND

Set Monument from survey flush with ground.

6" P. pine brs S28°W @ 92.6' marked X BT
A 2 1/2" BCSP marked COR 3, brs N89°25'02"E @ 122.00'
