CORNER RECORD FILE GUIDE (Rectangular Surveys)

Index
File No. 18 S. R. 12 E.

CORNER RECORD (SEARCH)
(Ref. FSM 7151.4)

R.D. BEND County DESCHUTES
Merid. WILLAMETTE N.F. DESCHUTES State OREGON

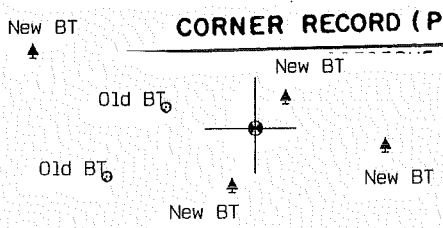
Corner location falls in an area which had been logged and then burned moderately hot in the B & B fire of 2003. Found stone of call size with faint marks on North and South faces. Rock was burned hot enough that it has spalled off the surface that was above ground. Found SW BT with old BT tag, a Ponderosa Pine Stump, burned, approx. 6 inches diam. remains, S.82°W, 114 lks. (75 ft.). No other evidence. A Ponderosa pine stump, burned, approx. 8 inches diam. remains, N.68°W., 70 lks. (46.2 ft.). No other evidence. A thorough search turned up no evidence of other BT's.

Bearing by hand compass.
Oregon State Plane Coord.
NAD 83, North Zone
International feet.
N. = 314793
E. = 7885153
elev. 3387
GPS Mapping grade
+/- 5 meters

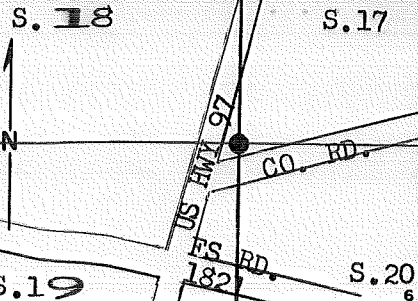
CORNER DIAGRAM

2" Brass-Capped Steel Pipe, rising 2", at NE side of intersection of U. S. Hwy. 97 and County Rd.

Set by Aubrey Perry.

Serves as T.B.M. Elev. 3848 381 by Level traverse from BM/H-102, Arnold Canal at railroad crossing.

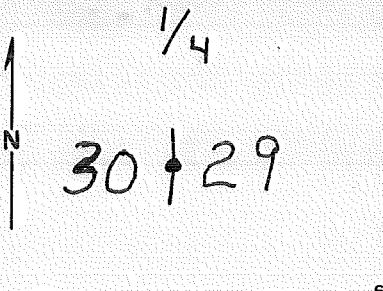
CORNER DIAGRAM

2" BRASS CAP SET IN CONC.

6 1/2" P.P N 39° W, 12.0 Ft

AT Fnc. Corner. Fnc. South & EAST
 Along Forest Boundary
 China Hat Road Across Canal South to
 Fnc. West to Corner.

8" PP N 54° E 27.0 Ft

BT & ATTEN. SIGNS ON BOTH BT'S

Carsonite Post & Signs 4° ft South

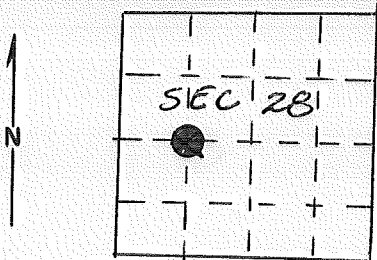
CORNER DIAGRAM

found 1. $\frac{5}{8}$ " iron pin set by sub'd. of
Sec 28.

2" x 30" gal. pipe w/ brass cap stamped
RISING 3"

1. p. pine ^{12"}/_{10"} dia. bears N 9° E 78 ^{25'}/_{10'} to center of tree (SCRIBED CW 1/16 S 28 BT)
 2. " " ^{10"}/_{13"} " S 82° W 110 ^{38'}/_{10'} " " (SCRIBED CW 1/16 S 28 BT)
- scribed - painted - tagged

APPEARS THAT NEW FENCES WERE BUILT TO THE BRASS CAPS SET BY BRUCE RODGERS. (2/11/83)

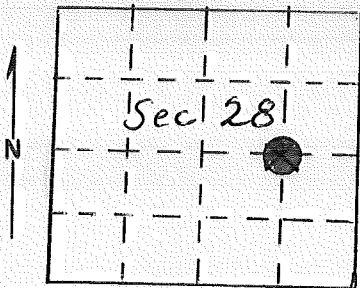
CORNER DIAGRAM

Found $5/8$ " iron pin

2" x 30" gal. pipe w/ brass cap stamped
RISING 4"

1. 1" pine ^{10 1/4"} dia. bears N 21° E 66 ^{28'} to center of tree (SCRIBED E 1/16 S 28 BT)
 2. " " ^{13 1/4"} " " 563° E 69 ^{87'} to the center of tree " E 1/16 S 28 BT
- (scribe d - painted - tagged)

APPEARS THAT A NEW FENCE WAS BUILT TO CONFORM TO BRASS CAP

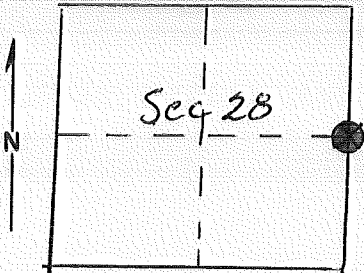
CORNER DIAGRAM

2" pipe

2" x 30" gal pipe w/ brass cap stamped
RSG. 9"

1. p pine 1 1/2" dia bears N 29° E 10⁵³' to center of tree (SCRIBED 1/4 S 27 BT)
 2. " " 1 1/4" " " S 64° E 34⁶⁸ " " (" 1/4 S 27 BT)
- scribed - painted - tagged

APPEARS NEW FNC WAS BUILT TO CONFORM TO BRASS CAP

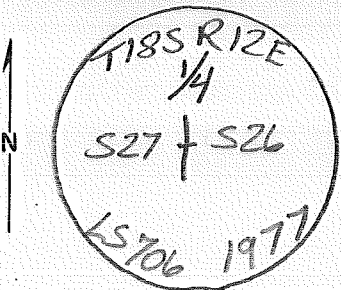
CORNER DIAGRAM

Found: $1\frac{5}{8}$ " Iron Pin firmly set w/ Original Stone along side w/ $\frac{1}{4}$ visible on the East Side.
 $18" \times 10" \times 10"$

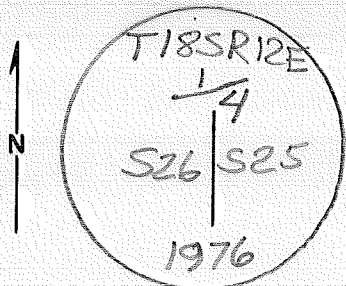
CORNER DIAGRAM

AT Orig $\frac{1}{4}$ Cor Secs 25/26 mon by Thompson, Pengra & Davis in 1869 with a Volcanic stone, 12"x10"x7", Firmly set 6" in Grnd, MKd " $\frac{1}{4}$ " on East Face.

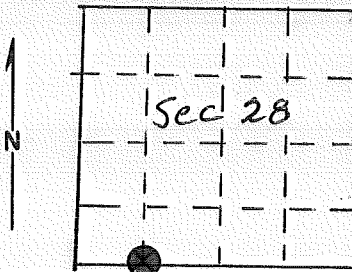
CORNER DIAGRAM

Found 5/8" iron pin - Woodside Ranch
Homesites has sub'd. sec 28 - set correct 1/16th
corners.

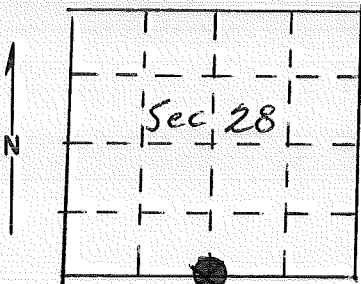
CORNER DIAGRAM

2" pipe and cap

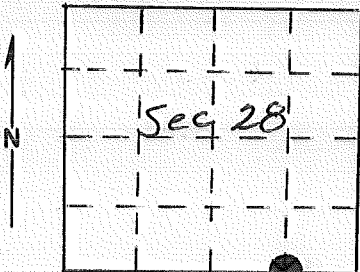
CORNER DIAGRAM

5/8" iron pin

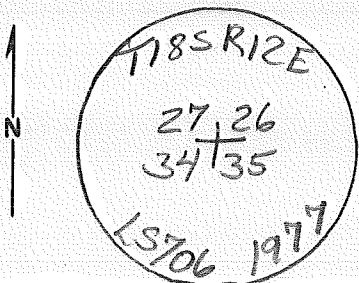
CORNER DIAGRAM

Found: Original stone w/hack marks in ring
of rock undisturbed 15" x 10" x 8"

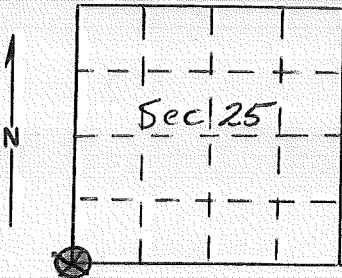
CORNER DIAGRAM

Found original stone & 5/8" iron pin

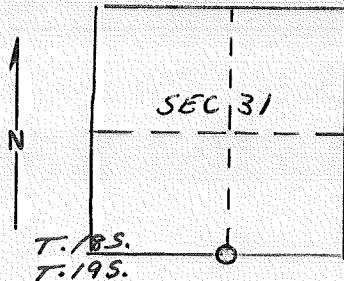
CORNER DIAGRAM

NOTHING

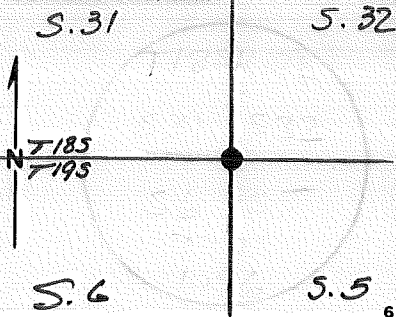
CORNER DIAGRAM

AT ORIG Cor Secs 5, 6, 31, & 32, On South Bdy T188R12E, Mon By Thompson, Pengra, & Davis. in 1869 with A Volanic Stone, 20"x15"x10" (Rec 20"x12"x10") Loosely set 2" in Grnd. MKD with 1 notch on West & 5 notches on 2
