CORNER RECORD (SEARCH)
(Ref. FSM 7151.4)

T 19 S. R. 11 E. R.D. BEND County DESCHUTES
Merid. WILLAMETTE N.F. DESCHUTES State OREGON

USDA-FOREST SERVICE

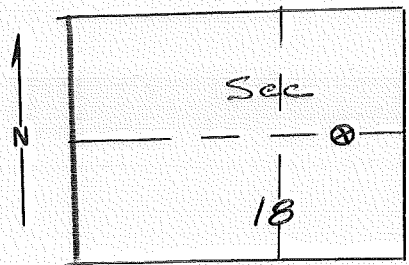
Tract or Survey No. _____
 Cor. No. L-4
 R.D. Bend County Deschutes
 N.F. Deschutes State Oregon
1/16 Sec.

nothing

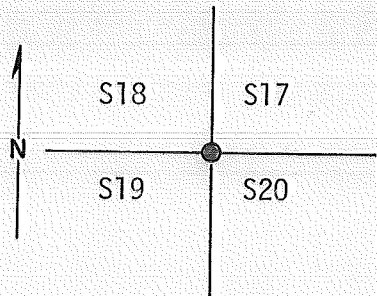
NW COR. S. 20

Found 18" X 10" X 6" Notched Stone in Mound of Stones and Hub and Tack. Set 5/8" Iron Rod (MBA 1974)

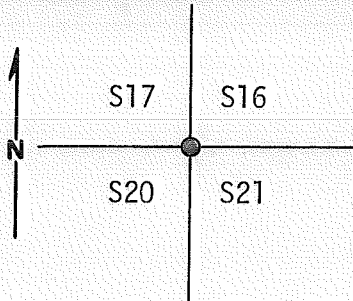
R.D. FT. ROCK County DESCHUTES
 N.F. DESCHUTES State OREGON
 Tract or Survey No. SEC 20
 Cor. No. ~~NE COR~~ N-09
 NE Cor Sec 20

Found 16" X 8" X 8" Stone in Mound of Stones; (MBA 1976)
 Set 5/8" Iron Rod to Mark Location
 Found 3 B.T.s with no scribing B. Rogers, 1973
 (not of record)

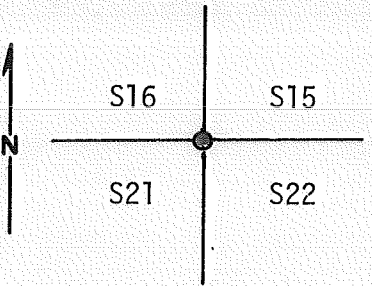
NW COR. 522

Found "16" x 12" x 6" stone in mound of stone.

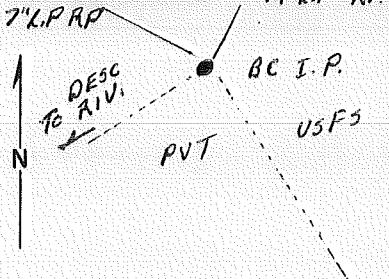
1/2" rebar flush with ground and 3 FT high 2"x2" yellow post with metal strip marked "N.E. Prop Cor"

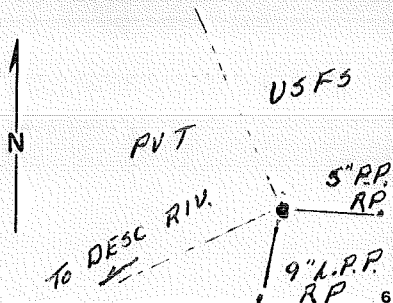
No. 0-5 BT 195 R. 11ER.D. BendCounty DeschutesMerid. WillametteN.F. DeschutesState Oregon

$\frac{5}{8}$ " rebar flush with ground and 4 FT high 2"x2" yellow post w/metal strip marked "Prop Cor"

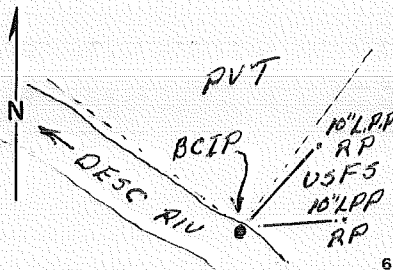
$\frac{5}{8}$ " rebar rising 8" above ground in a mound of stone just below high water line of Deschutes River. Also a 3FT high 2"x2" yellow post w/metal strip marked "S.W. Prop Corner" 2

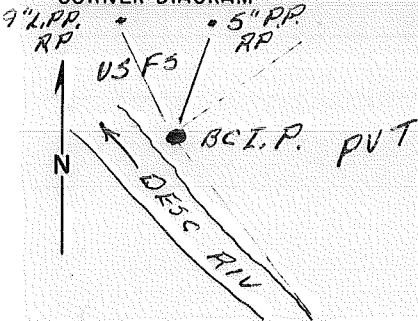
5/8" rebar rising 8" above ground in a mound of stone and a 3 FT high 2"x2" yellow post with a metal strip marked "S.W. Prop Cor."

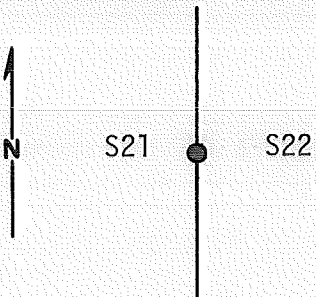
W/A COR. S. 22

Found 12" X 10" X 10" Stone (GLO)

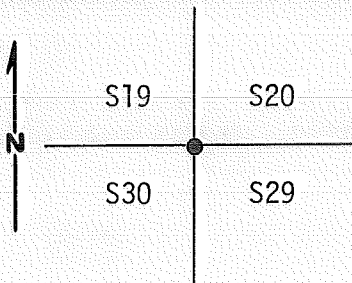
T 19S R. 11E R.D. FT. ROCK County DESCHUTES SW COR. S. 20
Merid. WILLAMETTE N.F. DESCHUTES State OREGON NE COR. S. 30

FOUND 24" X 12" X 5" Stone (MBA 1976)
Set 5/8 Iron Rod to Mark Location by Rogers 6/73

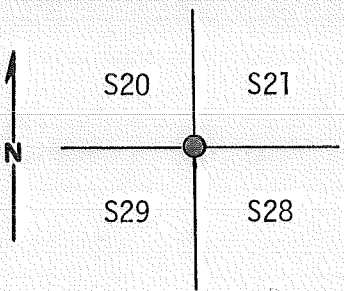
T 19S R. 11E N.D. _____ County DESCHUTES SE COR. S. 20
Merid. WILLIAMETTE N.F. DESCHUTES State OREGON NW COR. S. 28

Found 18 x 12 x 10 unmarked stone.
Found blazed line trees North and South out from corner. Found blazed trees around corner with no reference distances. (Not of record)

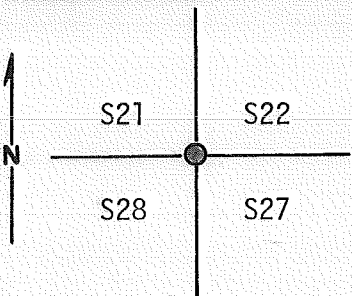
Found 16" X 12" X 6" Stone (G.L.O.)

SET 5/8" I.R. Replaced with 2-1/2" X 30"
Galvanize Iron Pipe and 2-1/2" Brass Cap *RSNG 8 1/2"*

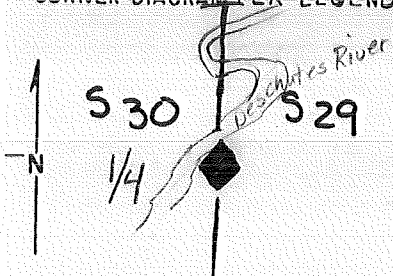
COR. of SEC. 29

1/4 Cor Located by McC, Bryant + Assoc. in Dec. 1973 Fd Orig. BT + Set 5/8" I.R. from It and tied to Sunriver Grid.

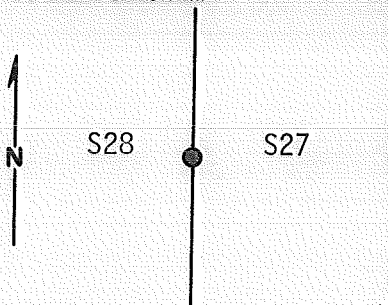
E/4 COR. S. 28
W/4 COR. S. 27

Found 14" X 12" X 6" Stone with scribed "1/4"

MONUMENT : DESCRIBE NEW MONUMENT SET, OR WORK DONE TO PRESERVE EXISTING MONUMENT Set 5/8" Iron Rod - replaced with 2-1/2" X 30" Galvanized Pipe with 2-1/2" Brass Cap	T19S R11E 1/4 S28 S27 1980 PLS930 9
---	---

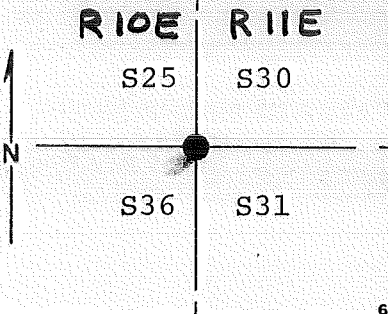
2" X 30" GALVINIZED IRON PIPE WITH BRASS CAP

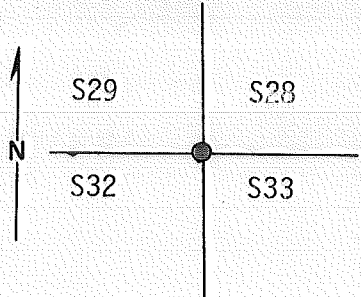
Index File No. 0971 **CORNER RECORD (SEARCH)** (Ref. FSM 7151.4) Tract or Survey No. _____ Cor. No. V-09
 T 19S R. 17E R.D. FT. ROCK County DESCHUTES SW COR. 5.28
 Merid. WILLAMETTE N.F. DESCHUTES State OREGON NE COR. 5.32

Found 18" x 10" x 8" stone and square head bolt in mound of stone.

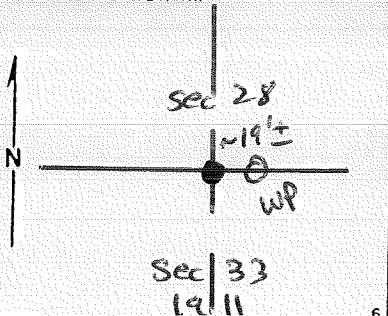
N/4 Sec 33

DESCR (11) - NORTH 1/4 CORNER OF S.33
 FOUND 2-1/2" BCSP BURIED 6" PER CS 4379. ND
 N = 812368.14 E = 4679736.08

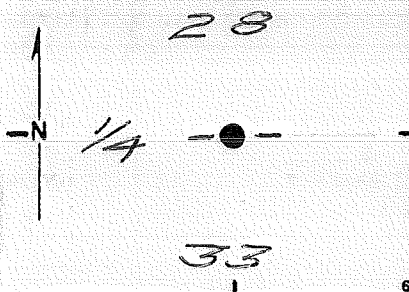
Aluminum capped aluminum pipe
rising 4" in stone collar.

FOUND 3-1/4" ACAP RISING 4" IN A STONE COLLAR
WITNESS CORNER TO N 1/4 CORNER OF SEC. 33 PER
LAND CORNER RECORDATION FORM NO. 427. THE
TRUE CORNER BEARS N 89°14'19"W AT 18.96' (M)
(RECORD IS N 89°35'49"E AT 18.92')
N = 812367.89 E = 4679755.04

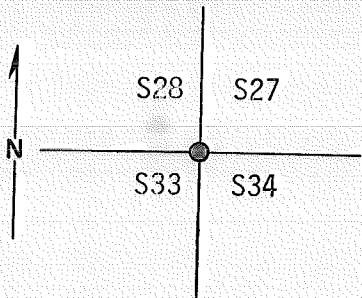
Found 18" X 14" X 5" Stone in Mound of Stone

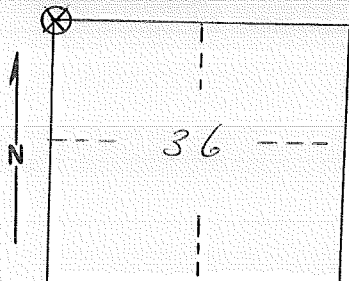
No. V-21T 19 S R. 11 ER.D. D-3County DeschutesMerid. WillametteN.F. DeschutesState Oregon

Original stone 14 x 12 x 10"
 Fd mound of Rocks 10 or 12 - ^{not} find any notches
 Several of approx. size but could find any notches
 This is original corner however -

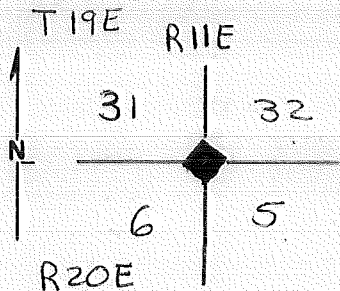
*Found Nothing, Corner in Meadow
See Marx and Chase Survey of Sec. 5
Could not find their corner point*

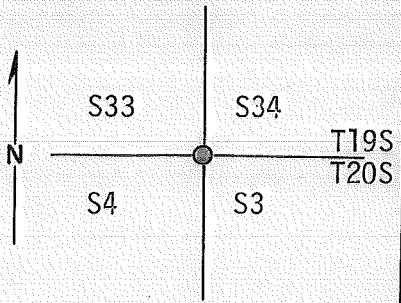
Found 8" X 8" X 15" Stone and 2" X 2" Rough Hewn Post
