T 20S, R 9E M W

LAND CORNER RECORD

1. T. 20S R. 9E No. A-1 Cor. SEC Mer. Will State OREGON (Rectangular) N. F. DESCHUTES Dist. BEND

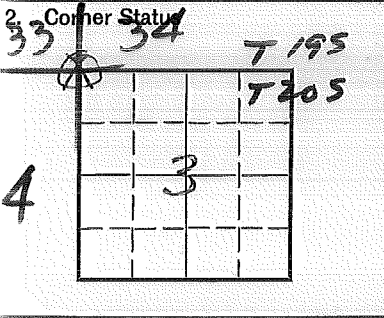
A-13 5680-2

1. T. 20S, R. 9E No. A-13 Cor. SEC Mer. Will State OREGON (Rectangular) N. F. DESCHUTES Dist. BEND

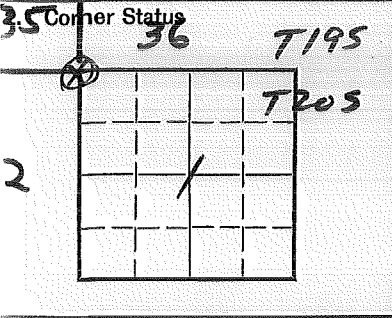
A-21 5680-2

1. T. 20S, R. 9E, No. A-21 Cor. SEC Mer. WILL State OREGON (Rectangular) N. F. DESCHUTES Dist. BEND

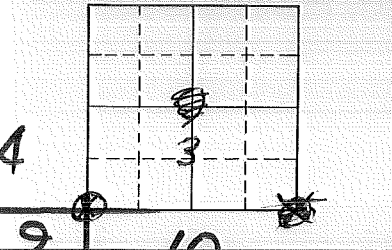
1. T. 205 R. 9E No. E-13 SEC. 9-10 Cor. 34 Mer. Wm State Oregon (Rectangular) N.F. Deschutes Dist. Bend E-13

4. Description of Corners:
 Files of rocks in place
 Good condition
 Dimensions above ground 34"

5. Investigation Notes:
 Two bearing trees found.
 Species: Snag Ponderosa
 Diameter 18" 34"
 Bearing 129° 323°
 Distance 7.5' 19'
510 54

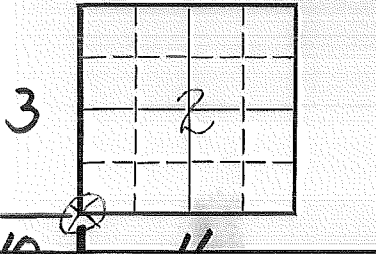
1. T 20S R 9E No. 171 Cor. SEC. Mer. WM State Oreigo (Rectangular) N. F. Reschutes Dist. Beno

4. Description of Corners:
Blazed tree in place
Good condition

5. Investigation Notes:
One beaving tree found
Species: Snag (Ponderosa)
Diameter: 30"
Beaving - 302°

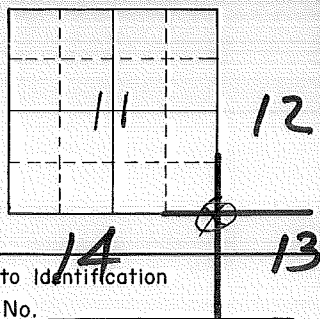
1. T. 20S R. 9E No. J-21 Cor. 1-12 Mer. Wm State Wm (Rectangular) N.F. Dechutes Dist. Bend

4. Description of Corners:
Metal post in place
Fair condition

One Bearing Tree Found
Species: Ponderosa
Diameter: 30"
Bearing: 82°
Distance 42.5'

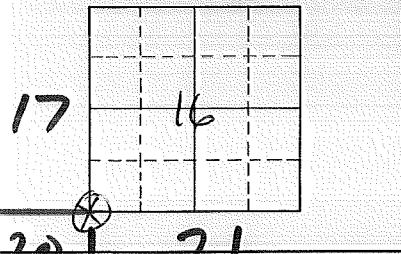
4. Description of Corners:
Piles of Rocks
Good Condition
Dimensions above ground 20"

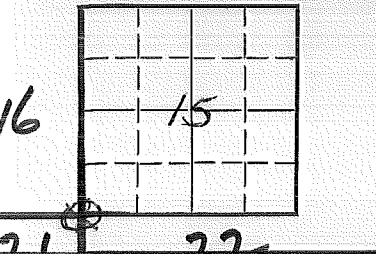
2. Corner Status N-13

1. T. 20S R. 9E No. ~~16-15~~ Cor. SEC Mer. 21M State (Rectangular) Oregon N. F. Deschutes Dist. Bend 2

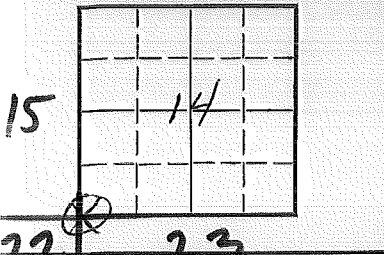
1. T. 20S., R. 9E., No. N-17 Cor. SEC Mer. WILL State ^(Rectangular) OREGON N. F. DESCHUTES Dist. BEND

4. Description of Corners:
ROCK PILE IN PLACE
GOOD CONDITION
DIMENSIONS ABOVE GROUND 30"

TWO BEARING TREES FOUND
SPECIES: PONDEROSA
DIA: 4" 36"
BRNG: 160° 297°
DIST: 15' 35'

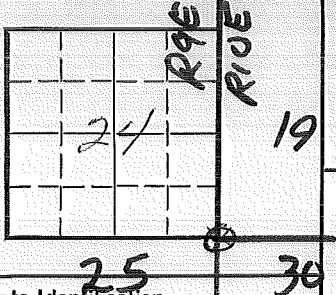
2. Corner Status R-25

4. Description of Corners:
Tree in place
condition fair

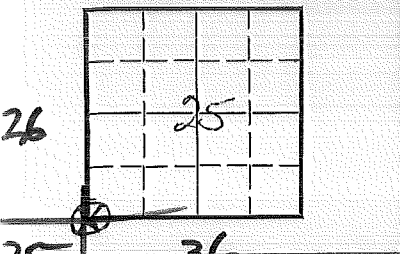
4. Description of Corners:
Pile of rocks in place
Condition Good
Dimensions above ground 18"

Three Bearing Trees found

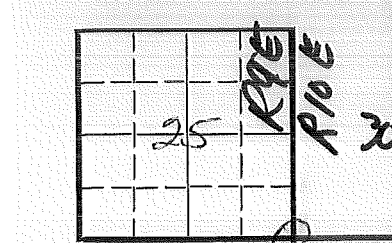
2. Corner Status V-25 3. Original Description Vol. Page Where Recorded

4. Description of Corners:
Stake in place
Condition Good
Dimensions above ground 30"

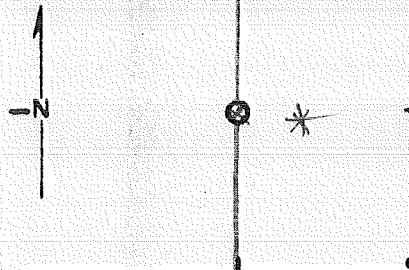
CORNER DIAGRAM per legend

DESCRIBE CORNER MONUMENT FOUND

DESCRIBE BEARING TREES OR OTHER OFFICIAL ACCESSORIES FOUND

E. BT.

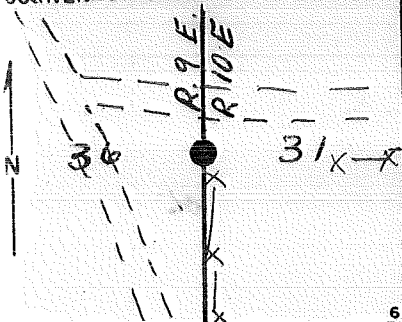
W/4 COR. of SEC. 31

2 1/2" brass-capped steel pipe rising 1" above ground level with original stone on east side of pipe

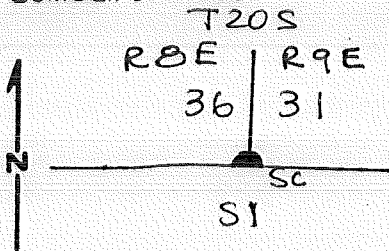
Section 31

Found original post hole underneath a mound of stones.
 A Ponderosa pine, 33" dia., brs. S 48°W, 12 lks.(7.9'), faint scribing visible.
 A Ponderosa stump, uprooted & on its face in the NW BT position.
 A Ponderosa pine, 45" dia., brs. N 56°E, 71 lks.(46.9'), chopped open & burnt face.
 A Ponderosa Stump, 39" dia. brs. S 66°E, 96 lks.(63.4'), BT blaze at bottom.
 Distances measured to the face of original BT's.
