Index File No. 2153

CORNER RECORD (SEARCH) Contract or

Cor. No. C-21

T 21 S. R. 13 E. R.D.

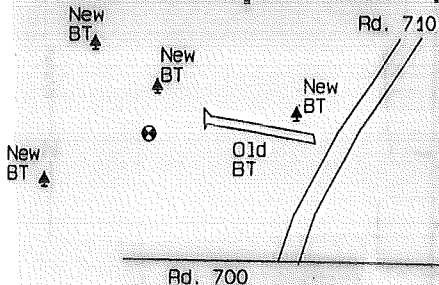
No evidence of original post.

No evidence of NW BT. Area has been logged and burned.

A Pine windfall, in the NE BT location, with face and scribing exposed. Set cor. at GLO bearing and distance from the stump hole.

- Set a 2 1/2" dia. x 30" long Steel Pipe surmounted by a 2 1/2" dia. Brass cap rising 6".
- A penny at base of pipe. A steel fence post 3 ft. North.
- A Ponderosa Pine 11" dia., N.12° E., 27.0 ft. mkd. 1/4 S1 BT.
- A Ponderosa Pine 9" dia., N.75° E., 106.0 ft. mkd. X BT.
- A Lodgepole Pine 11" dia., S.66° W., 64.8 ft. mkd. X BT.
- A Ponderosa Pine 11" dia., N.29° W., 92.0 ft. mkd. 1/4 S2 BT.

- Corner falls approx. 150 NW of intersection of closed road 710 with the 700 road.
- A brass washer, 1" dia. mkd. LS 2396 nailed to the blaze between the B & T of the scribing.
- Distances measured to the side center at the root crown.

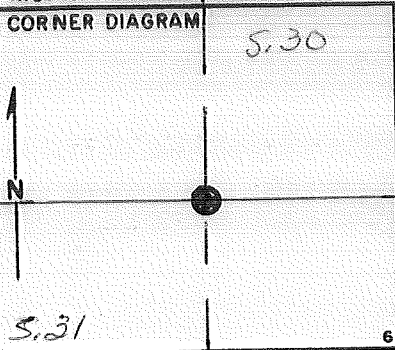
Tract or Survey No. \_\_\_\_\_ Cor. No. V-038

— NONE —

S.30 DYING 12" L. PINE W/VISI. SCRIBING

S.31 11" L. PINE, DEAD & DOWN

SET 2 1/2" x 32" ALUMINUM-CAPPED ALUMINUM PIPE  
 RISING 8" IN MOUND OF STONES

A 7" L. PINE BRS. S 41° E 15.8 FT., MKD. 1/4 S 31 BT; and  
 A 6" " " N 30° E 21.8 FT., MKD. 1/4 S 30 BT.

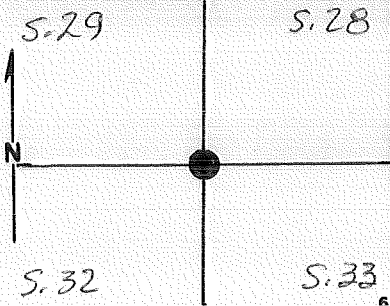
Cor. No. V-09

— NONE —

S. 32 = 15" L. PINE, DOWN & ROTTING W/VIS. SCRIBING  
 S. 29 = 24" DEAD L. PINE, W/VIS. SCRIBING

**MONUMENT:** DESCRIBE NEW MONUMENT SET, OR WORK DONE TO PRESERVE EXISTING MONUMENT  
 SET 2 1/2" x 32" ALUMINUM-CAPPED ALUMINUM PIPE RSG. 9"  
 IN A MOUND OF STONES.

AN 8" L.P. BRS. S52°W 8<sup>1</sup>/<sub>2</sub> FT., MKD. T21S R13E S32 BT;  
 AN 8" L.P. " S64°E 24<sup>1</sup>/<sub>2</sub> FT., " " " S33 BT;  
 A 7" L.P. " N68°W 35° FT., " " " S29 BT; and  
 A 7" LP " N48°E 8<sup>1</sup>/<sub>2</sub> FT., " " " S28 BT.

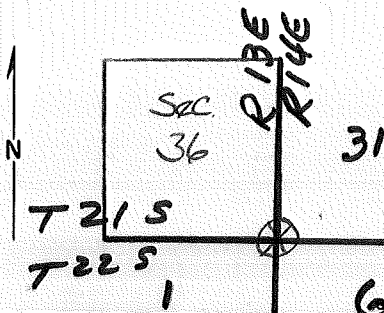
Cor.  
No. Z-25

Squared Post - I do not believe it is the original Post.
