**CORNER RECORD (SEARCH)**

Cor.  
No. J-09

T 21S R. 16E

R.D. Fort Rock

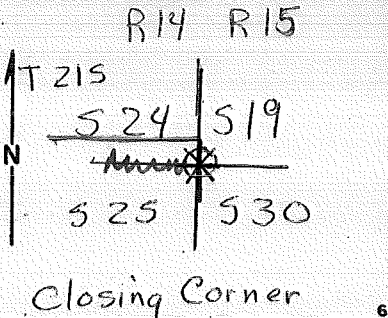
Tract or Survey No. \_\_\_\_\_  
Cor. No. R-1

Rock as described, In good Condition  
with scribe Marks

South BT Stump  
North BT - Down  
Located @ 500 ft. NW of Forest Rd. 2013

Loc. marker 20 chs. N. of cor.  
10/42 G.T. Rhoton  
Also - marker 18 chs. E. of corner. & 10 chs. S. of cor.

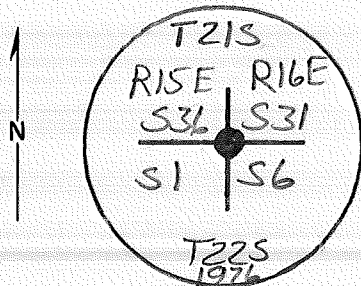
Tract or Survey No. \_\_\_\_\_ Cor. No. Z-25  
R.D. Ft Rock County Deschutes SE Cor Sec 36  
N.F. Deschutes State Oregon NW Cor Sec 6

AT Orig Cor Sacs 31, 36, 146, AT SW Cor T21SR16E. Mon. By Henry Mal Drum in 1900 with a Basalt stone 18" x 14" x 6" (Rec 16" x 12" x 6"), Firmly Set 9" in Grnd, mkd with 6 Grooves on Each Face.
