T 21S, R 8E, M 10

Index
 File No. 2551
 CORNER RECORD (SEARCH) (Ref. FSM 7151.4) ^{Contract or} Survey No. Cor. No. A-25
 T 21 S. R. 8 E. R.D. Bend County Deschutes NE Cor. of
 Merid. WILLAMETTE N.F. DESCHUTES State OREGON Section 1

LAND CORNER RECORD

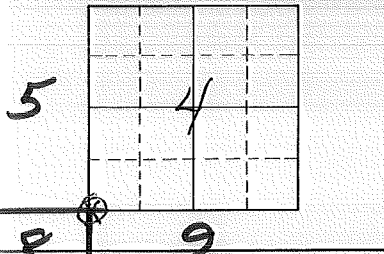
2. Corner Status E-9

4. Description of Corners:
Pile Rock
Fair condition

One Barry Tree Trunk	One Dead
Species: P. P.	P. P.
Diameter 18"	20"
Boring S 24° W	SE
Distance 24 1/2

Three down unable to determine standing position

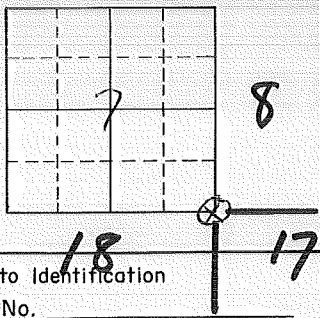
2. Corner Status J-5

5. Investigation Notes:
Ins Barry Trees Found
Species: P.P.
Diameter: 38" 30"
SE SW

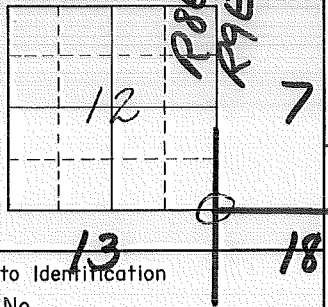
2. Corner Status J-25

4. Description of Corners:
Gr Tree - 4" diameter
Dwd condition

5. Investigation Notes:
One Bearing Tree. Blazed on 4 sides -
No scribbling but writing -
Sounds like crovisors garbage

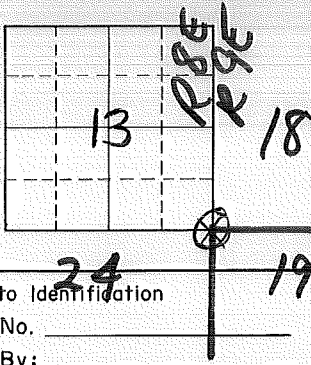
2. Corner Status N-25 3. Original Description _____ Vol. _____ Page _____ Where Recorded _____

4. Description of Corners:
Piles of Rocks
Good Condition

5. Investigation Notes:
Three Trees Found
Species: Ponderosa -
Diameter: 28" 17" 34" Dead
Bearing: N 50° E SE S 60° W
Distance: 30 1/2' 14 1/2' 43'

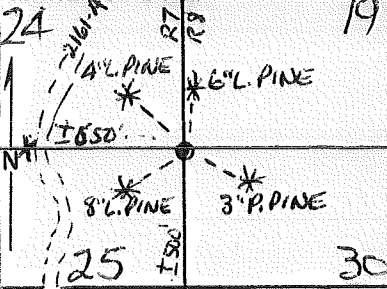
CORNER DIAGRAM

DESCRIBE CORNER MONUMENT FOUND
14" x 11" x 6" basalt stone -- had been moved for aerial photo target S70E 14.9 ft.

DESCRIBE BEARING TREES OR OTHER OFFICIAL ACCESSORIES FOUND
S-19, a 20" Pine, dead & down, scribed as called for
S-24, rootshards in location
S-25, a 6" L. Pine, dead & down, scribed as called for
S-30, a 7" L. Pine, dead & down, scribed as called for, but apparently moved for aerial photo target

Set 5/8" x 30" aluminum-capped steel rod, flush with ground in mound of stone, stamped as shown:

(Placed original stone alongside in stone mound)

- S-19, a 6" L. Pine Brs. N 02 E 20.00 ft., B/S "S19 BT", nail set in east side
- S-24, a 4" L. Pine Brs. N 40 1/2 W 17.19 ft., bark scribed "S24 BT", nail set in NE side
- S-25, an 8" L. Pine Brs. S 69 1/2 W 3.20 ft., B/S "S25 BT", nail set in SE side
- S-30, a 3" P. Pine Brs. S 66 1/2 E 28.02 ft., bark scribed "S30 BT", nail set in south side

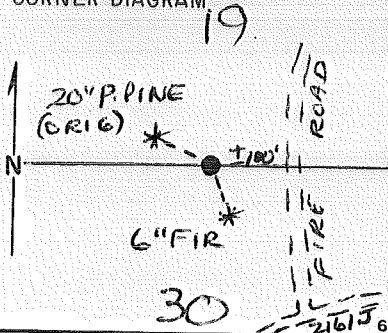
CORNER DIAGRAM

Nothing

S-19, a 20" P. Pine, scribed as called for
S-30, a 24" Pine stumps, sawn, scribed "┌"

Set 2 1/2" x 32" brass-capped galvanized steel pipe,
rising 4" above ground, stamped as shown:

S-19, a 20" P. Pine BRS. N 57 W 13.86 ft., (orig. bt), nail set in NE side

S-30, a 6" Fir BRS. S 30 E 43.81 ft., B/S "S30 BT", nail set in West side

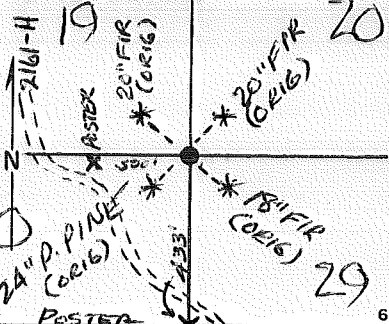
CORNER DIAGRAM

Nothing

- S-19, a 20" fir, scribed as called for.
 S-20, a 20" fir, scribed as called for.
 S-29, an 18" fir, scribed as called for.
 S-30, a 24" P. pine, scribed as called for.

Set 2 1/2" x 32" brass-capped galvanized steel pipe,
6" below ground, stamped as shown:

(set 5/8" x 30" steel rod alongside,
rising 12" above ground.)

- S-19, a 20" Fir Brs. N 26 W 19.66 ft., (orig. BT), nail set in NE side
- S-20, a 20" Fir Brs. N 34 E 7.74 ft., (orig. BT), nail set in SE side
- S-29, an 18" Fir Brs. S 54 E 18.93 ft., (orig. BT), nail set in SW side
- S-30, a 24" P. Pine Brs. S 37 W 28.58 ft., (orig. BT), anil set in NW side

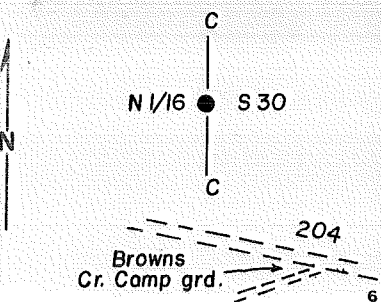
CORNER DIAGRAM

No original evidence found.

None

Set 2½" galvanized iron pipe and 2½" brass cap.

T 21 S R 8 E
C
N 1/16 | S 30
C
1978
L.S. 1046

Scribed two bearing trees:

A ponderosa pine 14" dia. bears S 84° W 82.63
A ponderosa pine 6" dia. bears S 77° E 71.38

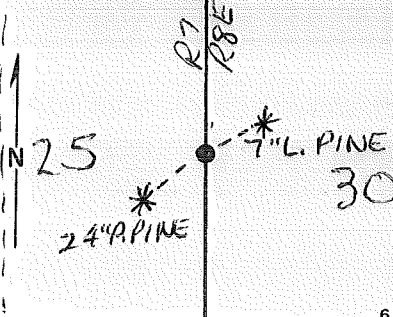
CORNER DIAGRAM

6" x 12" basalt stone rising 10" above ground with "1/4" chiselled into west face.

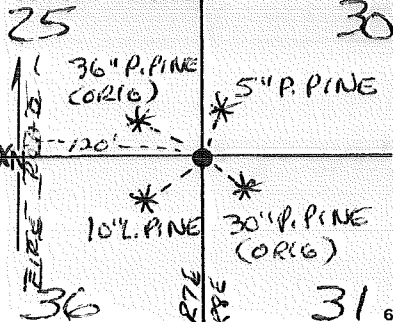
CORNER DIAGRAM

14" x 9" stone rising 9" above ground with 1 notch on south side and 5 notches on north side.

PK NAIL & STONE REPLACED BY 2 1/2" X 3/2"
BRASS-CAPPED STEEL PIPE ~ B. ROGERS 10/77

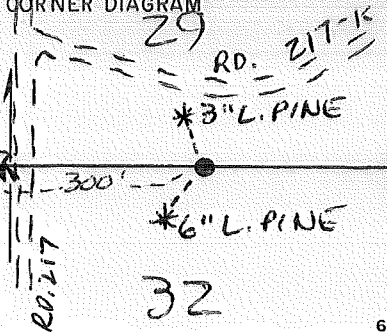
CORNER DIAGRAM

Nothing - A point on north edge of old wagon road.
S-32 BT would have been in south track of road

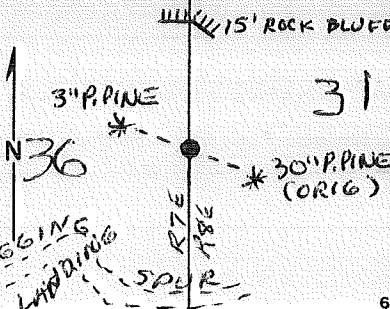
CORNER DIAGRAM

18" x 14" x 14" basalt stone with chiselled "1/4"
broken and moved by crawler tractor

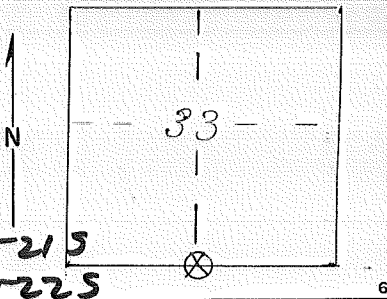
CORNER DIAGRAM

20" L.P. pine scribed B.T. on Eastern face
 about 10" above the ground.
 S BT

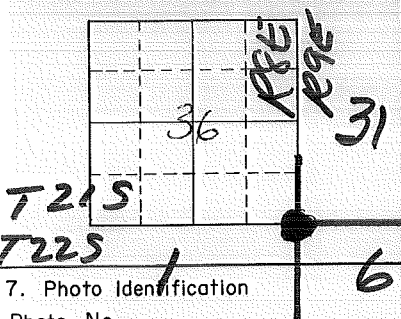
2. Corner Status Z25

4. Description of Corners:
 Post. _____
 Poor condition _____
 Dimensions above ground. 36"
