## US DA-FOREST SERVICE

Index

File No. 1130-0151T 21 S R. 9 EMerid. Wmt

Tract or  
Survey No. \_\_\_\_\_Cor.  
No. A-01R.D. Bend County DeschutesN.F. Deschutes State Oregon NW CC  
Sec. 6

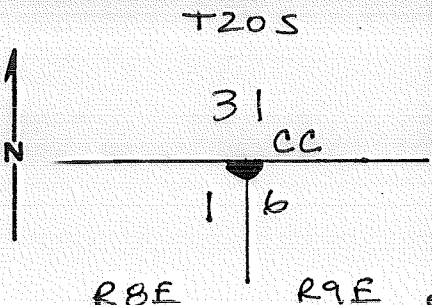
## CORNER DIAGRAM

Original corner post, 4 in. below ground, squared off and ending in a point 14 in. down.

A Ponderosa pine, 28 in. dia., S.11°W., 31 lks., with face &amp; scribing visible.

A Ponderosa pine stump, S.76°E., 29 lks., with BT blaze overgrown.

A Ponderosa pine, 19 in. dia., N.49°E., 32 lks., with face and scribing visible.

Distances to original B.T.'s measured to face.

A 2½ in. X 30 in. alum. pipe with alum. cap, set 26 in. in the ground. A penny at base of pipe. A steel fence post bears North, 3 ft.  
 Original BT, A Ponderosa pine, 19 in. dia., N.49° E., 21.1 ft. Not re-marked.  
 A Ponderosa pine, 28 in. dia, S.49° E., 53.6 ft., marked T21S R9E S6 B T  
 Original BT, A Ponderosa pine, 28 in. dia., S.11° W., 20.5 ft. Not re-marked.  
 A Grand fir, 8 in. dia., S.51° W., 34.3 ft., marked T21S R8E S1 B T

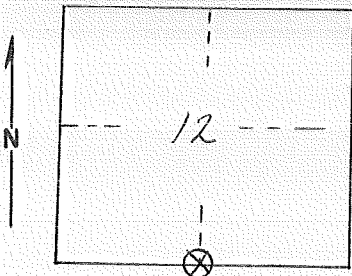
## CORNER DIAGRAM

wood post 1"x4" painted white

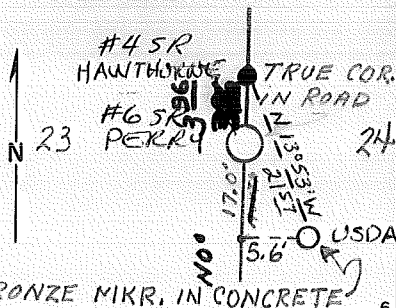
See  
Survey For H.O. ADAIR by Aubrey Perry 10/17/65  
SET: CERT. BOOK No. 1978 Run 2

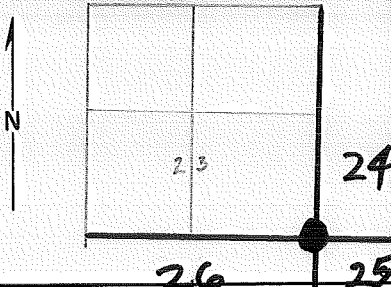
## CORNER DIAGRAM

~~2 1/2" PINE BEST OVER - NO CAP~~ReplacedSquare post about 3' NorthSEE: CORN. BOOK  
BC Set 1978\* See cards in Back  
of TZ1S R9E

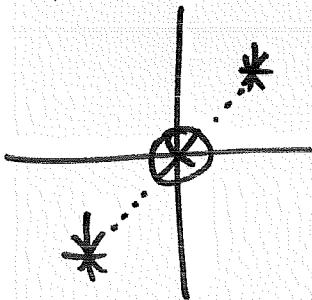
Fd 18" & 17" BTs w/ Scribers  
Fd Orig Cor Post scr. 1/4  
out of Ground

ORIG. 13T'S = 12" P. N69E 139 FT.  
12" P. S42W 59 FT.

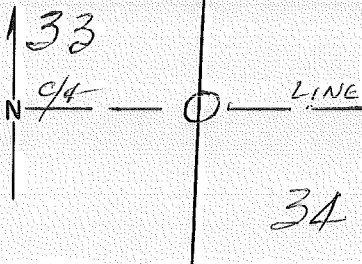
## CORNER DIAGRAM

F.S. Section Line board on tree and cruiser  
Tag says 1/4 cor is 1320'N.  
SF/NF 1978

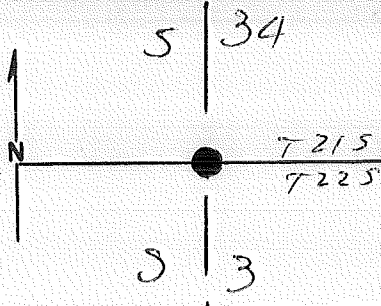
## CORNER DIAGRAM

~~2" PIPE~~ — SPURIOUS SEE: A-15  
BC by OTB&W  
1985 ~~SP/NT~~ 1978 R

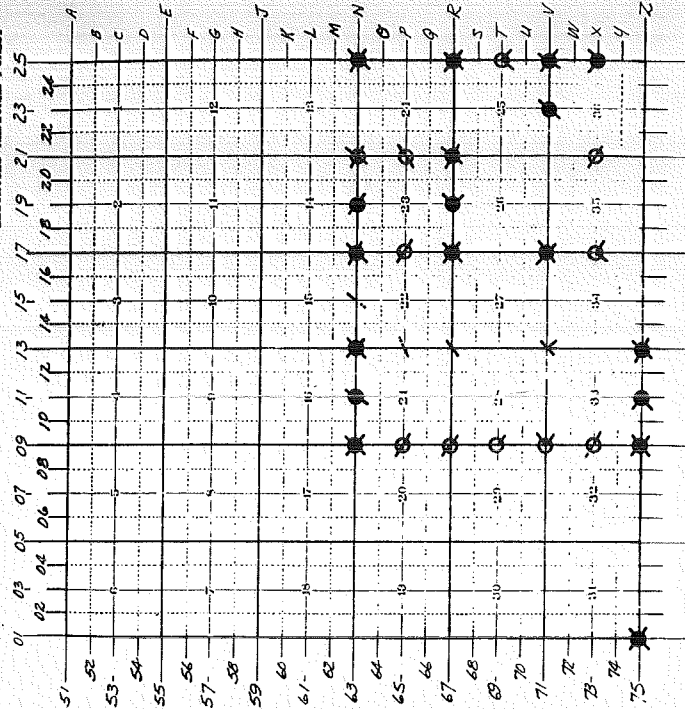
MONUMENT SET NOVEMBER 1978, wings indicate general BT position

MONUMENT FOUND, set prior to 1945 Platting Lev.

BT's FOUND (beyond state authority to monument).

BT's FOUND, ONE DETERIORATING ( " ).
