T 235 R 13E M W

CORNER RECORD (SEARCH)

T 23S R. 13E

N.F. Deschutes State Ore.

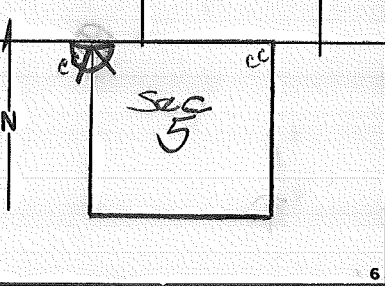
Tract or Survey No. _____
Cor. No. A-5

Squared Post

1 B.T. down & dead

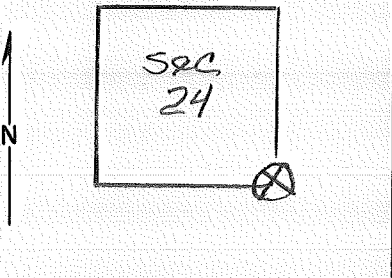
Index File No. R-25

Stone 12x10x8"
OS st above the grd. in Good condition

30' Pine B.T. bears N62°W 48 lks
in good condition.

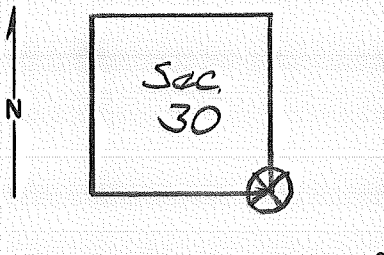
Index File No. V-5 CORNER RECORD (SEARCH) (Ref. FSM 7151.4) Tract or Survey No. _____ Cor. No. V-5
 T 23S R. 13E R.D. Fort Rock County Lake
 Merid. Will N.F. Deschutes State Ore.

3 BT.'S
 NE dead & down
 NW not recovered
 others in good condition

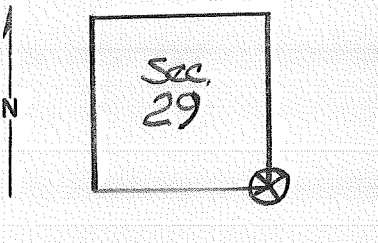
Wood Post as described in fair condition.

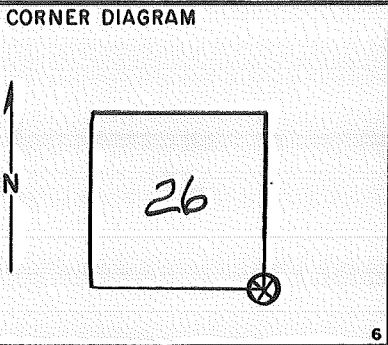
Index File No. V-21 CORNER RECORD (SEARCH) (Ref. FSM 7151.4) Tract or Survey No. _____ Cor. No. V-21
 T 23S R. 13E R.D. Fort Rock County Deschutes
 Merid. Will N.F. Deschutes State Ore.

Found 4 B.T.'s with USFS Tags.

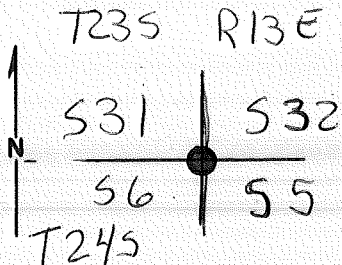
The Monument was not found.
Determined at record bearing and distance from the remains of the original bearing trees.

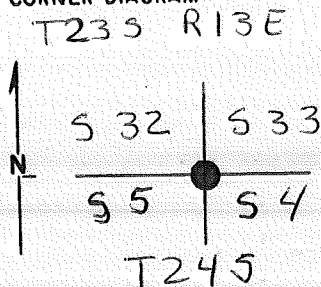
NO original monument found. Determined corner point from record bearing and distances from the remains of the original bearing trees.

- 1/ A ponderosa pine, 27" diam., bears N. 48° E., 50 lks. dist., with scribe marks BT visible on open double blaze.
- 2/ A root hole, bears S 58° E., 50 lks. dist., with a downed ponderosa pine alongside, 13" diam., no marks visible on open and burned double blaze.
- 3/ A root hole, bears N. 20° W., 11 lks. dist., with a downed ponderosa pine alongside, 6" diam., with scribe marks
