T 24S R 13E M. 111

CORNER RECORD FILE GUIDE (Rectangular Surveys)

CORNER RECORD (SEARCH)

# LAND CORNER RECORD

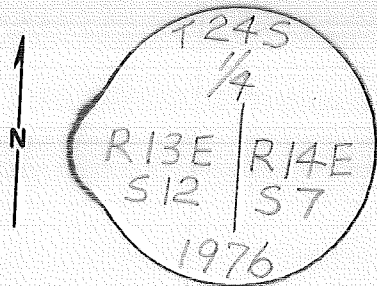
**CORNER DIAGRAM**

AT ORIG.  $\frac{1}{4}$  COR. SECS 7 & 12 ON W. BDY.  
T 245 R 14 E, DET. FROM ORIG. BEARING & DIST.  
OF HENRY MELDRUM'S ORIG. 1880 B.T.'S  
BOTH HEALTHY.

A FORKED PINE, 37" DIAM., BEARS N 15° E  
57 LKS. DIST., WITH SCRIBE MK "4" VISIBLE  
ON PARTIALLY OPENED FACE OPENED BY ME.  
A PINE, 25" DIAM. BEARS N 32° W, 32 LKS  
DIST., MKD. WITH COMPLETELY HEALED BLAZE.

FOREST SERV. ROAD 2227  
Found Stone in good condition, 6" above ground.
