Index
File No. 0151
CORNER RECORD (SEARCH) Contract or
(Ref. FSM 7151.4) Survey No. Cor. No. A-01
T 26 S. R. 8 E. R.D. Crescent County Klamath NW Cor. of
Merid. WILLAMETTE N.F. DESCHUTES State OREGON Section 6

CORNER RECORD (SEARCH)
(Ref. FSM 7151.4)

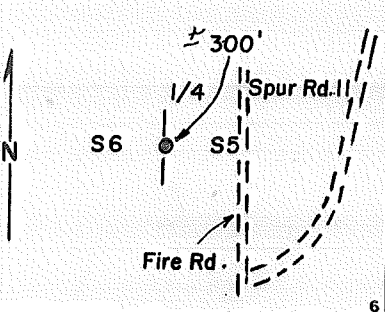
CORNER DIAGRAM

No original evidence found.
 FD 2 1/2" BC Buried 6" Below surface @ NW edge of RD.
 55' south of sign post

No original bearing trees found.
 FD 2 BT's (over)

Set 2½" galvanized iron pipe and 2½" brass cap.

Scribed two bearing trees:

A ^{19"}~~7"~~ D.B.H. Lodgepole pine bears S 56° 40' W 46.10' ok
 A ^{19"}~~7"~~ D.B.H. ~~Lodgepole~~ pine bears S 83° E 94.44' ok
 PP

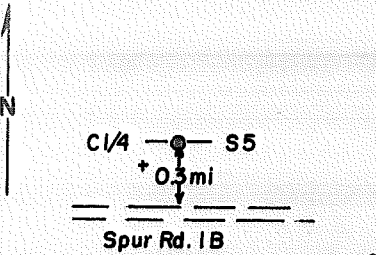
CORNER DIAGRAM

No original monument found.
FD BC in good condition (over) 6/93 sk

No original bearing trees found.
FD 2 BT's (over)

Revisited 5188 By K. Greer - FOUND BC and 2 BTs in good condition

Set 2½" galvanized iron pipe and 2½" brass cap.

Scribed two bearing trees:

An 8" D.B.H. Lodgepole pine bears N 81° 20' East 57.50' ok

A 9" D.B.H. Lodgepole pine bears S 10° 40' East 20.56' ok

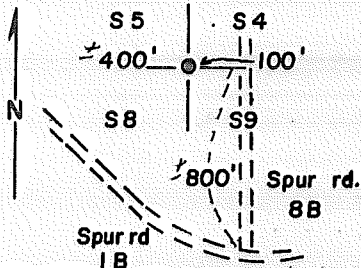
CORNER DIAGRAM

No original monument found.

4/97 - Found BCSP lying on the ground at the foot of a root wad from a LPP. which blew over. Re-established cap from BTs. See updated Cert. 2

No original bearing tree evidence found.

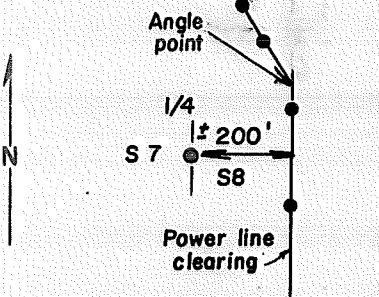
CORNER DIAGRAM

No original evidence found.
FD 2 1/2" BC Filing 4" in good condition

No original bearing trees found.
FD 2 BTs (over)

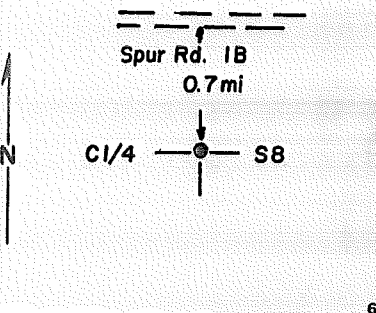
CORNER DIAGRAM

None
FD BC 6/93 sk (over) rising 4"
T26S R8E
C1/4 + S8
1978
LS 1104

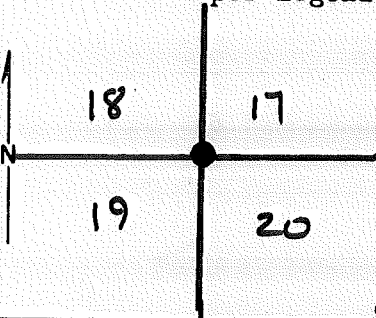
CORNER DIAGRAM per legend

BCSP RSG. 4" ABOVE GROUND.

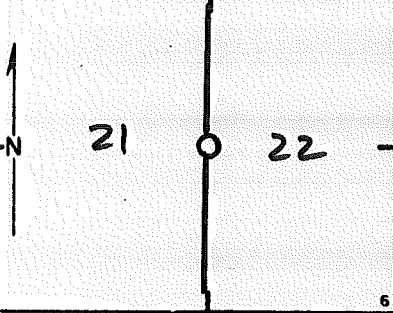
CORNER DIAGRAM per legend

SFNF

SFNF - AREA HAS BEEN BURNED OVER...

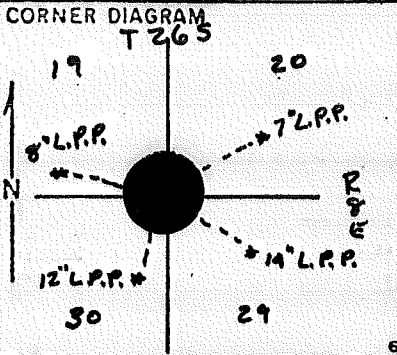
DESCRIBE CORNER MONUMENT FOUND
S. F. / N. F.

DESCRIBE BEARING TREES OR OTHER OFFICIAL ACCESSORIES FOUND
Sec. 19 12" Pine snag scribing visible
Sec. 20 8" Pine scribing visible
Sec. 29 14" Pine No visible scribing
Sec. 30 6" Pine down scribing visible.

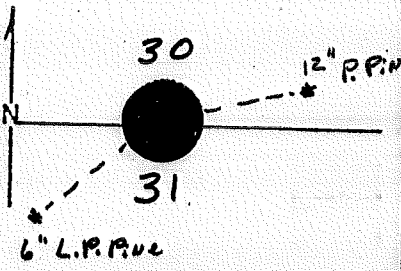
CORNER DIAGRAM

S. F. N. F.

found SE BT Scribing Visible

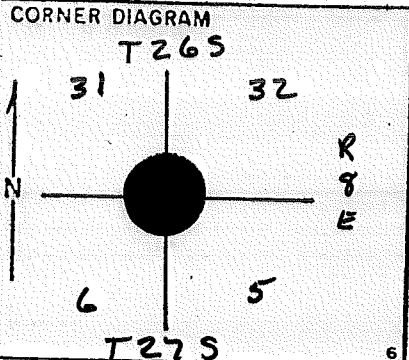
DESCRIBE CORNER MONUMENT FOUND
S. F. N. F.

DESCRIBE BEARING TREES OR OTHER OFFICIAL ACCESSORIES FOUND
Sec. 32 11 1/2 Pine Scribing Visible
Sec. 6 32" Pine No Visible Scribing.

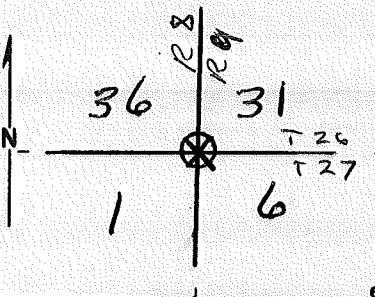
CORNER DIAGRAM

Corner Common to Sections 36, 1, and 6.
Corner consists of a Stake in place, broken at ground level.
Triangular 4x4", 36" inches.
